September 25, 2006

Ref: Foundation Movement Inspection

[REDACTED]
Garland, Texas
Geo No. 06 - 347

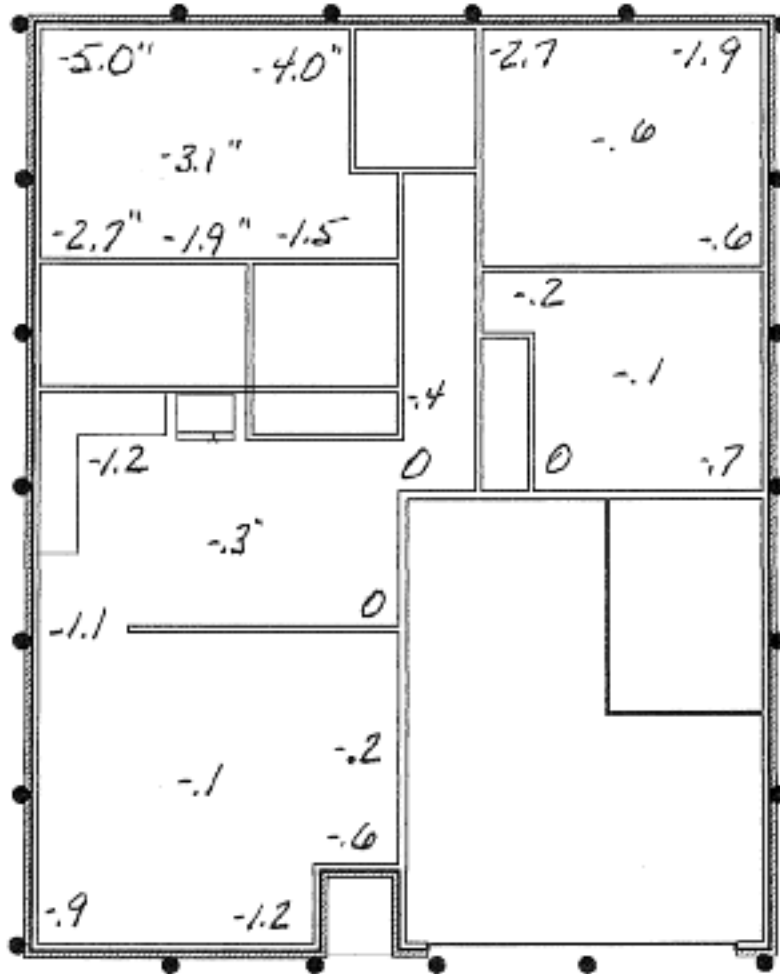
Pier Location Plan
not to scale

Root Barrier (consult an Arborist)
Approx 25 l.f. long

● represents the location of new piers to be installed

As can be seen on the attached drawing, the foundation is about 5" out of level. The high area is in the middle of the house and the low area is in the master bedroom. It is my opinion that most of the slab diselevation is the result of post construction foundation movement, but a portion of the diselevation may have been built into the slab at the time of its construction.

As we discussed at length today, if time allows, I recommend that the root barrier in the back yard be installed as soon as possible. Then I recommend that the foundation at the back portion of the house be observed for a year or so. This is to allow the soils to rehydrate from the negative effects of the tree. As the rehydration occurs, some upward rebound of the foundation will occur, including in the middle of the master bedroom. However, this typically takes several months. During the observation period, the homeowner should be diligent in watering the soils around the foundation, especially if the ongoing drought continues; this will aid in the rehydration process.

1. Install a root barrier between the tree in the back yard and the foundation. Typically, the root barrier ditch is 10 to 12" wide. For estimating purposes, the root barrier should be 3 feet deep and installed the barrier no closer than 4 to 5 feet from the foundation. An Arborist should be consulted prior to the installation of the root barrier and he should determine the proper depth of the root barrier (a function of how deep the roots are for the particular species of tree) and also the length of the barrier. Preferably, the root barrier should be a permanent barrier and not be subject to future penetration by roots as they attempt to grow back towards the foundation. An excellent & permanent barrier is to completely fill the ditch with a low strength concrete. However, because of the expense of this technique (using concrete as the barrier), many homeowners decide to install a plastic membrane in the ditch and backfill the ditch with dirt. This latter technique, using a plastic membrane, is considered a temporary barrier because the tree roots will, after a few years, eventually be able to penetrate through the barrier - or grow over, around or under the plastic membrane. This will require additional homeowner maintenance. A plastic barrier (in lieu of the concrete) that is typically used is a 20 mil thick reinforced plastic sheeting, **Permalon X210R** (available from Reef Industries 800-231-6074) (or approved equal). Another product that can be used is **Polyguard 650** (Polyguard Products, Ennis, Texas 972-875-9425).

2. I recommend that portions of this foundation be underpinned. Refer to the attached Pier Location Plan and Pier Details for additional information.
